# MINE SAFETY INVESTIGATION UNIT

INFORMATION RELEASE

## Double fatality

<b>Incident date</b>	15 April 2014
<b>Event</b>	Major rib burst in an underground coal mine
<b>Location</b>	Austar Coal Mine, Hunter Valley NSW

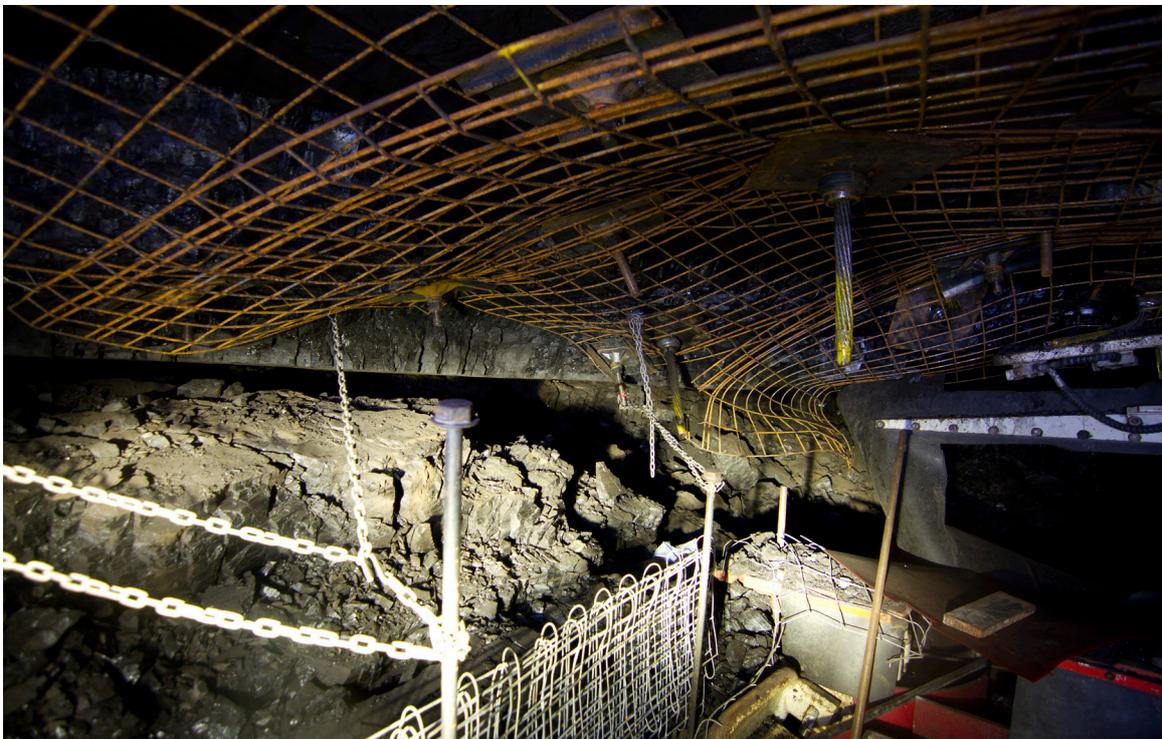
Rib on the left of the bolter miner after the workers were recovered. - Photograph by Investigation Unit

Two of the workers were on the left hand side of the bolter miner when a major burst of coal from the rib occurred. During this event a large section of the left rib that was supported with various lengths of bolts and mesh lost confinement and moved sideways into the roadway where the two men were working. Rib material engulfed both men who died at the scene.

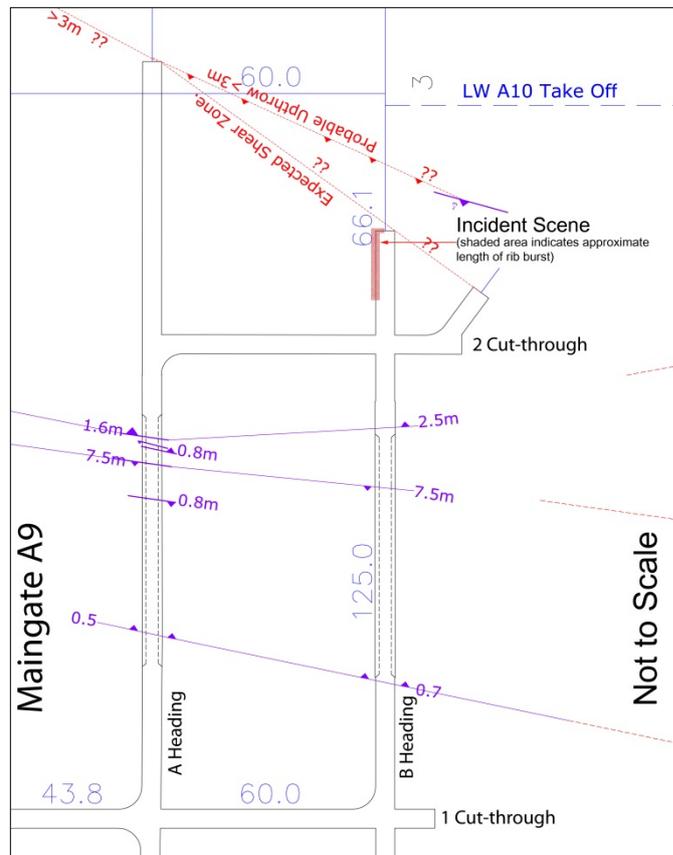
Plan of the incident site supplied by the mine.

The incident occurred at 9.05 pm on 15 April 2014. The incident site was in maingate A9, B heading about 25 metres inbye from the second cut-through. It was about 10 kilometres from the mine entrance and 555 metres below the surface. At this depth the rib and roof strata of the coal seam is subject to significant stress.

This particular heading is in a geologically disturbed zone near an upthrow fault and shear zone. The workers were mining toward the upthrow fault when the incident happened.

Steel mesh and bolts supported the roof and ribs at the incident site. A combination of steel mesh and chemically anchored roof bolts and cable bolts supported the roof. A combination of steel mesh, chemically and mechanically anchored bolting systems supported the rib. The extent and nature of the bolting is yet to be confirmed.
