Investigation report

Serious inrush incident at
Cadia East mine 21 February 2010

Extract of report prepared by the NSW Mine
Safety Investigation Unit

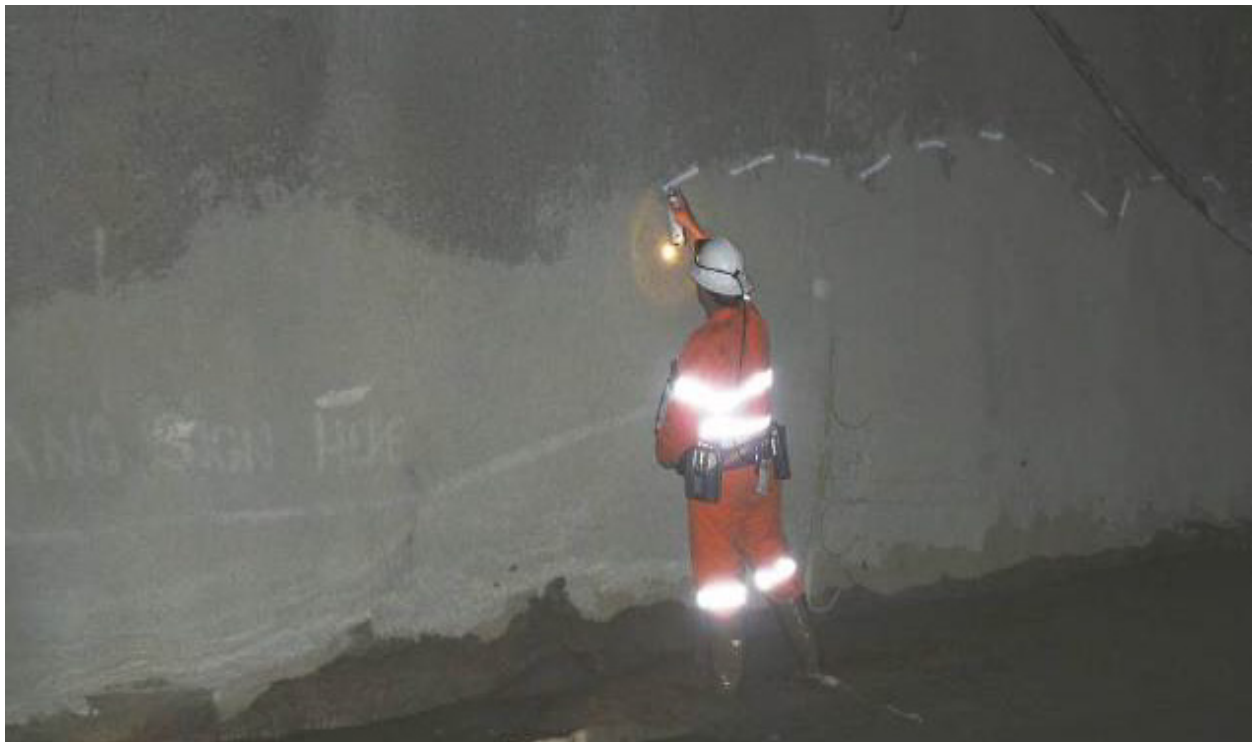
Photograph 1: Dried mud on the wall near VR5A shaft shows the height the material reached as it flowed to the base of the shaft.

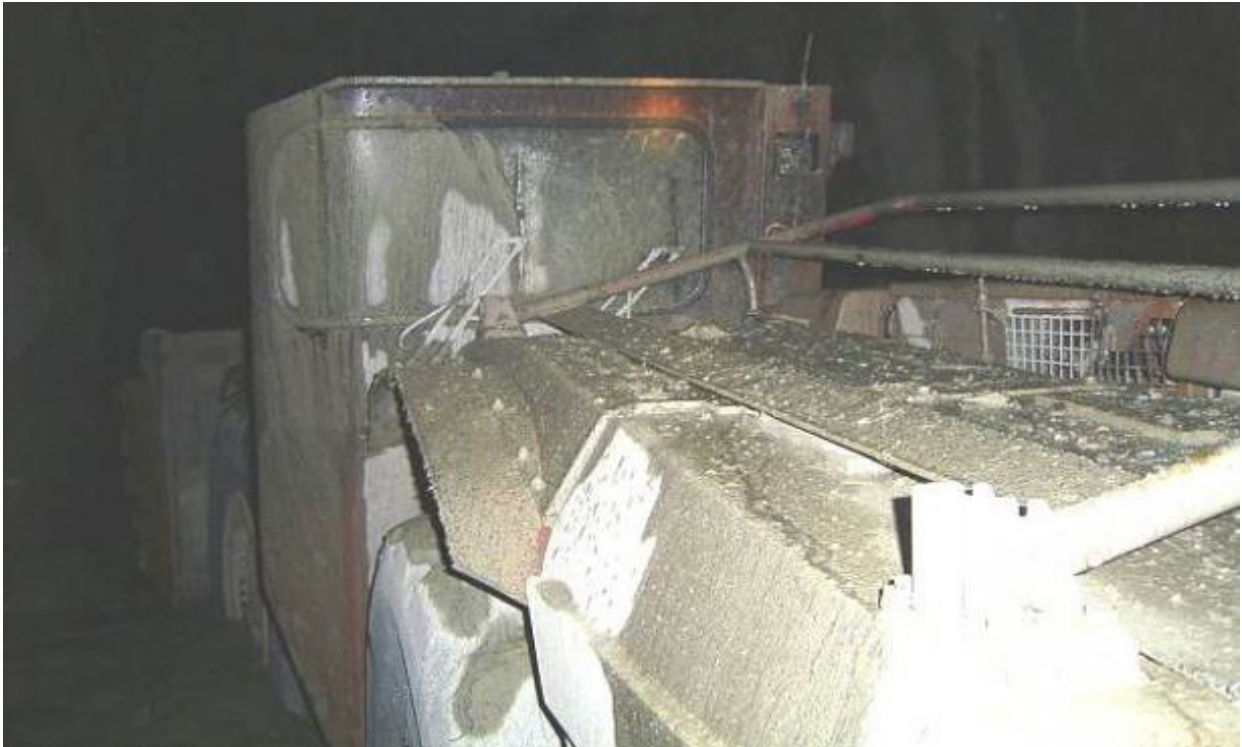
The inrush of material pushed the bogger 30 to 40 m back down the drive. The material from the base of the shaft flowed 814 m to the top of the VR5B ventilation shaft. The top of VR5B was about 100 m vertically below the base of VR5A.

Photograph 2: Rear view of the bogger that was pushed down the drive below VR5A shaft. The mud material coated the bogger up to the cabin level. Photograph courtesy of Cadia East mine.

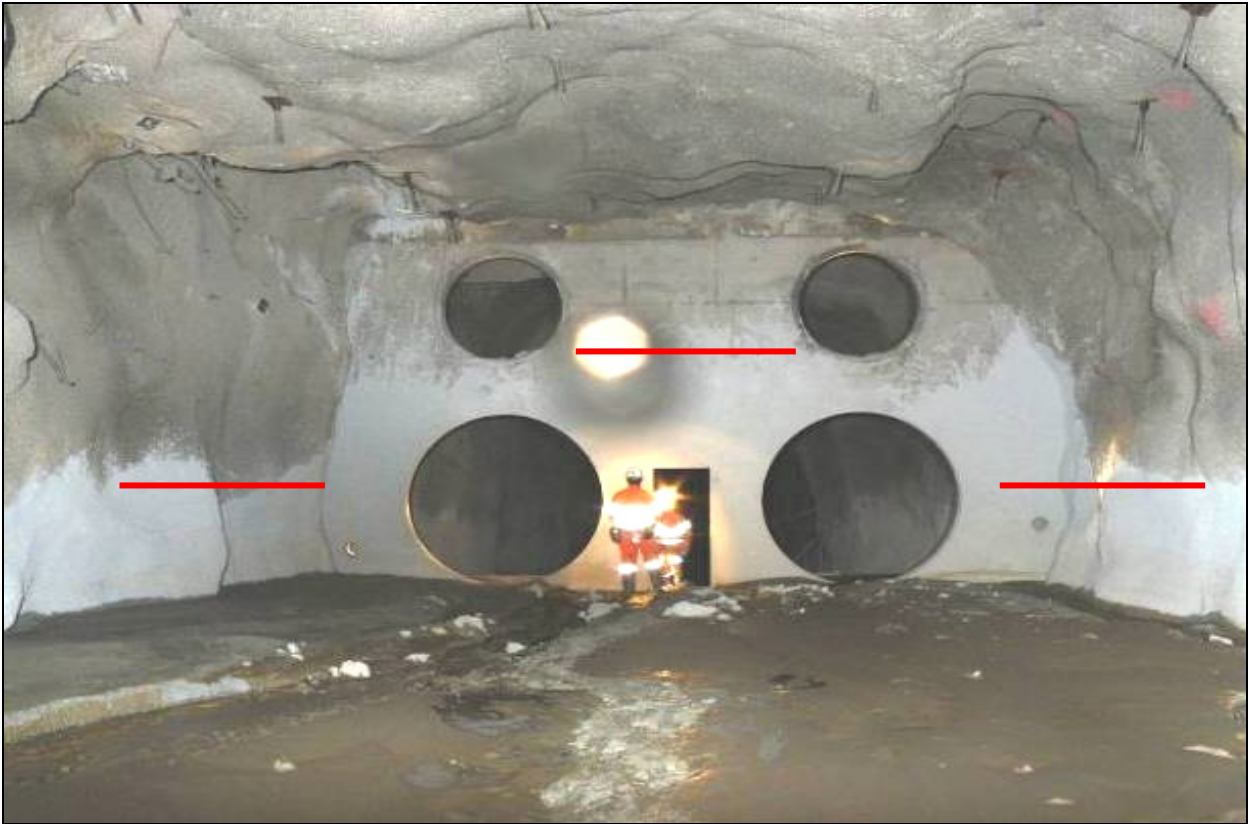
Photograph 3: Ventilation wall about 350 m from the base of VR5A shaft. The two outer red lines show the approximate height of the inrush flow. The centre red line shows the height of the turbulent flow when it splashed on the ventilation wall.

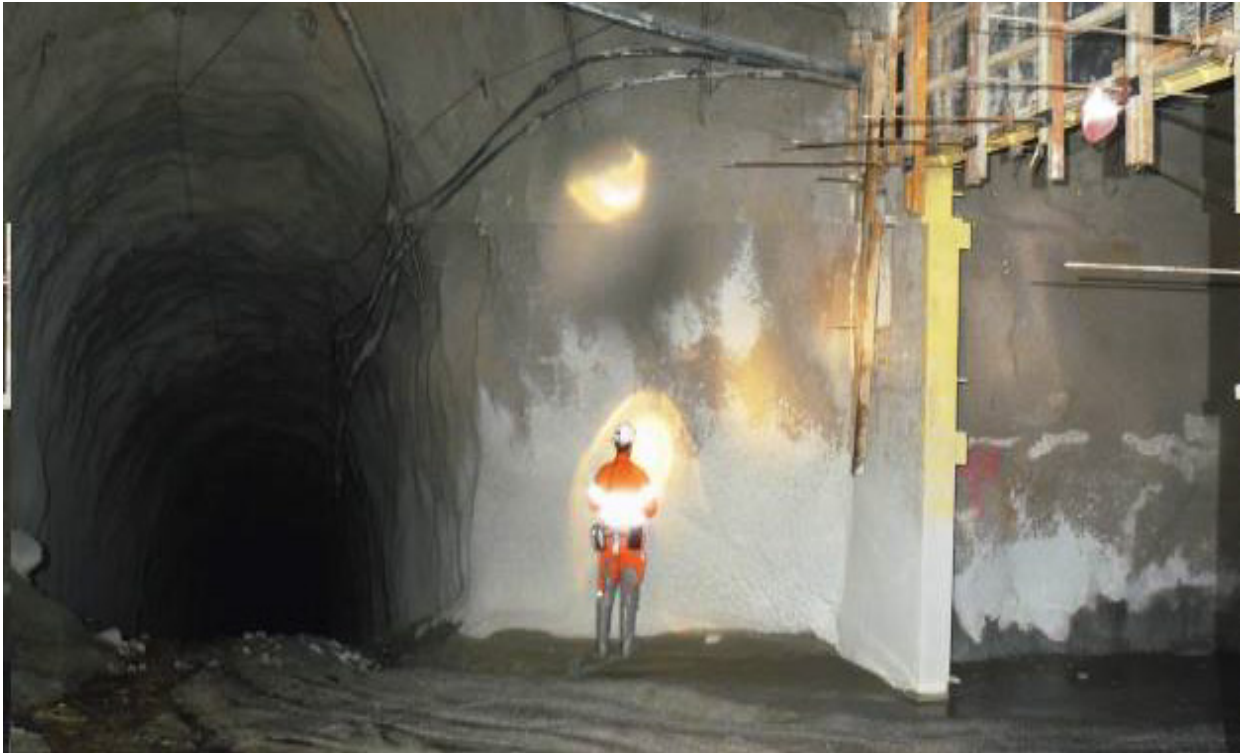
Photograph 4: The roadway intersection 550 m from base of VR5A shaft showing the height of the turbulent flow on the wall beyond the ventilation structure.

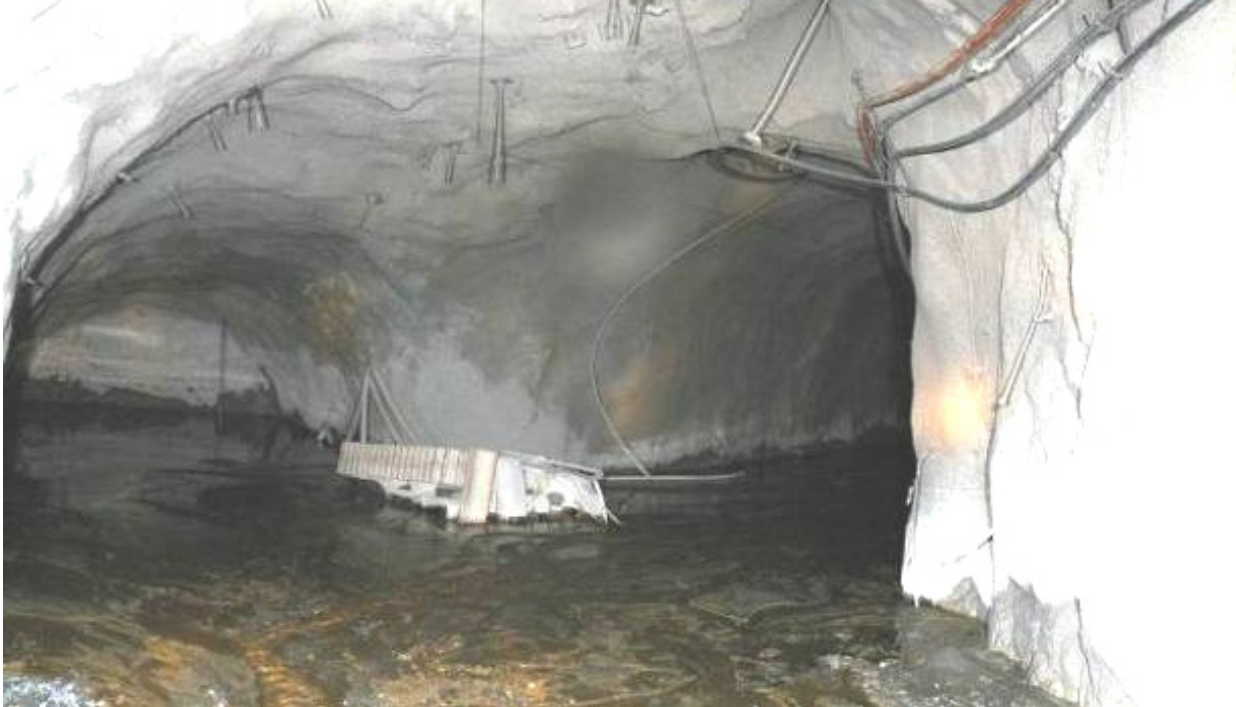
The inrush material travelled through the holes in the ventilation structure and continued along the ventilation drive. It washed a 5.7 tonne, unmanned, mini excavator that was close by to the structure along the drive and close to the top of the open VR5B shaft. See image below.

Photograph 5: The mini excavator that was washed along the drive and close to the top of VR5B shaft. The excavator is on its side with one track visible. The top of VR5B shaft is in the drive to the right of the buried excavator.
