Investigation report

**Report into a fatality at the Grasstree Coal Mine
Middlemount, Queensland on 6 May 2014**

16 May 2018

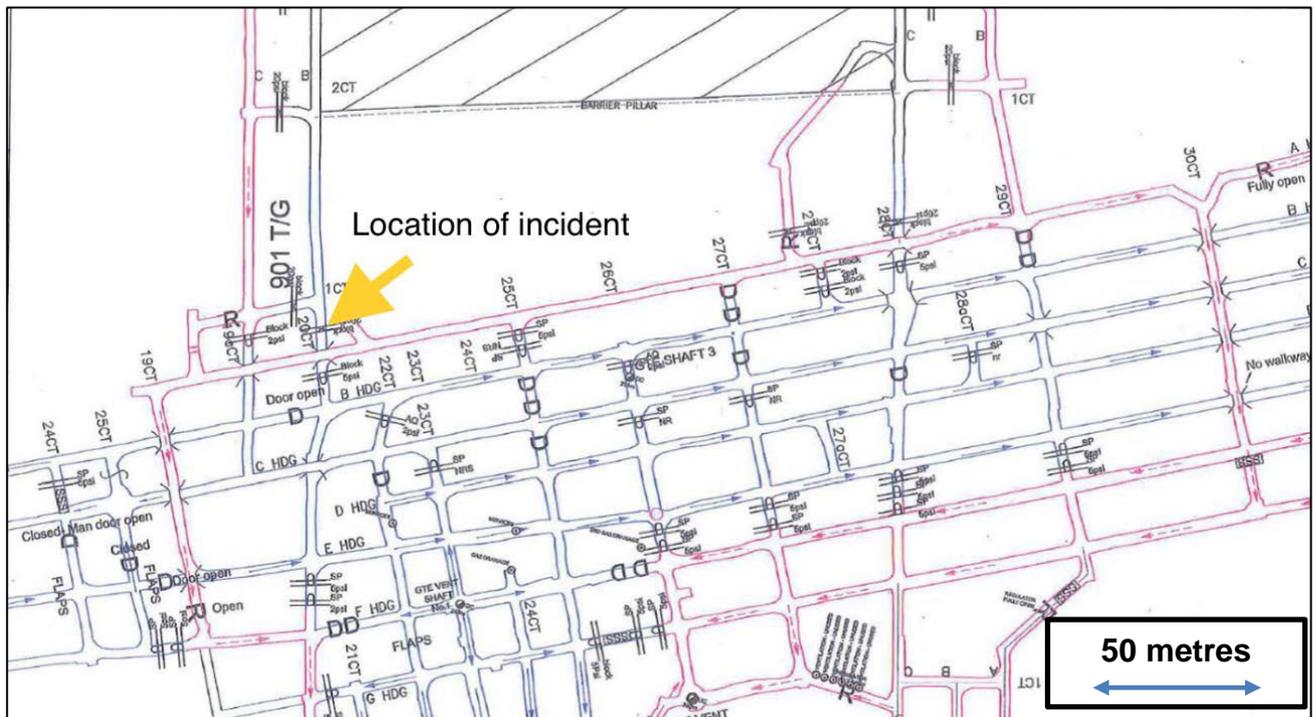
Diagram 2: Location of incident

At approximately 1.05pm, Mr McGuire opened the hatch at 0-1 cut through B Heading 901 tailgate by using a spanner to access the sensor. The hatch had been closed with a nut and bolt arrangement. As a result of opening the hatch, Mr McGuire inhaled irrespirable atmosphere and was fatally injured.

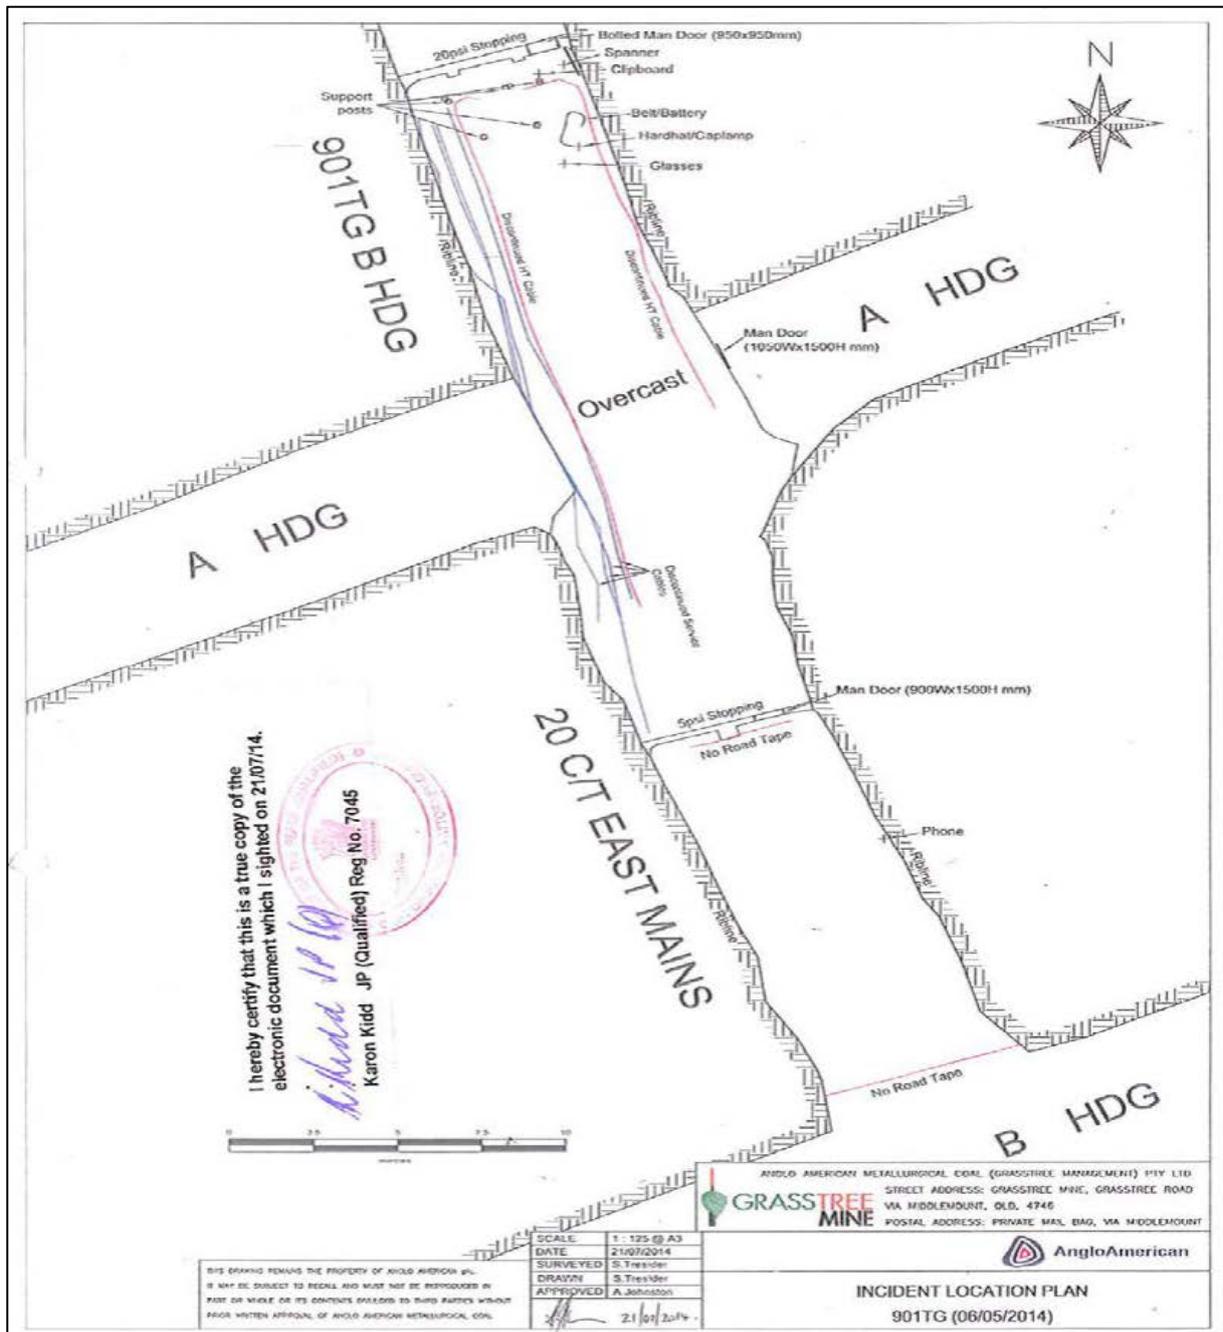
Diagram 3: Survey of the accident scene

With the door jammed open, the men returned to A Heading return (via 25 cut through). The VO entered 20 cut through overcast via a man door and observed Mr McGuire collapsed at the entrance to the 0-1 cut through B Heading 901 tailgate seal and called "*man down, man down*". The MSO then followed the VO through the 20 cut through overcast man door.

The VO and the MSO attended to Mr McGuire and observed his leg caught in the door of the hatch and that he was slumped back in the opening on the overcast side of the seal. After releasing his leg from the seal hatch, attempts were made to revive him using CPR.
