SAFETY ALERT

DATE: September 2021

Lift arm failure on load haul dump (LHD)

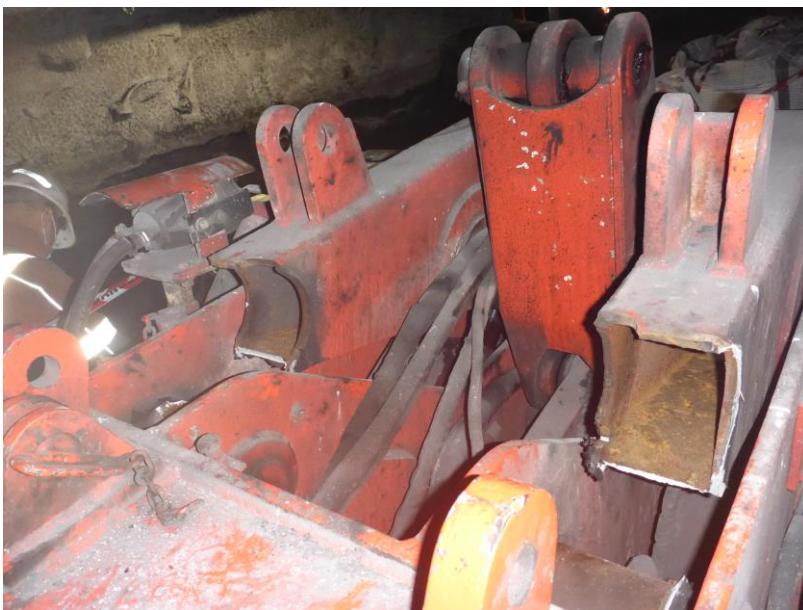
On 2 September 2021, an operator connected a loaded four-pallet duck-bill pod to an Eimco 130 LHD via the quick detach system (QDS) at pit bottom. The operator then drove the LHD a distance underground before stopping to wait at a set of block lights. As the operator stopped, the lift arm frame welds failed and the pod and lift arms dropped to the ground. No one was injured in the incident.

Figure 1: Weld failure at lift arm pivot boss connection

- The lift arm appears to be the ED7 or LS170 lift arm identified as BD0002087 in the “Sandvik rubber-tyred vehicles technical bulletin TB0819”.
- The lift arm had not been upgraded in accordance with the TB0819 technical bulletin.
- The lift arm had undergone non-destructive testing (NDT) using magnetic particle test methods for crack detection on 22 June 2020 and previously on 18 April 2017, with a ‘nil detectable cracks’ result.
- The lift arm remained in the LHD front frame for both above mentioned NDT examinations.
- The failed weld was not inspected during the NDT examinations as it was deemed inaccessible (see Figure 2).
- A portion of the failed weld has visible dust and corrosion indicating the crack had existed for some time. This is in an area where a partial visual inspection is possible. (See Figure 1).

- Review any Eimco 130, ED7 or LS170 LHD models that has not had the recommended upgrades in accordance with the OEM technical bulletin.
- Develop a risk-managed approach to implement the recommended OEM technical bulletin upgrades, as required.

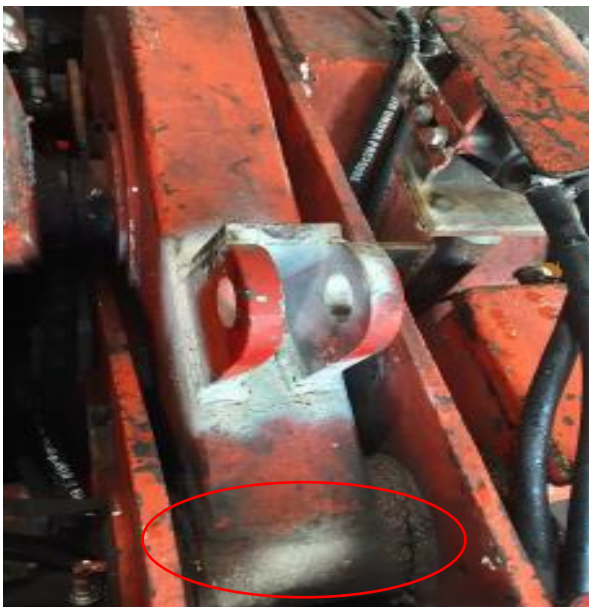
Figure 2: Area not accessible to NDT

- NDT reports adequately meet the site NDT protocols for each specific plant model.
 - NDT and inspection programs consider difficult to access areas.
 - Where safe to do so apply a load to areas being examined when conducting visual inspections to facilitate easier visual detection of cracks between NDT examinations.

- Provide advice to customers (mine operators) of areas that are inaccessible or untested which should be included for a complete assessment, compliant with OEM or mine standards or procurement specifications.
